**DEPARTMENT OF TRANSPORTATION**

Contract #: 04-0120F4Cty: SF/ALA Rte: 80 PM: 13.2/13.9File #: 69.28**WELDING INSPECTION REPORT****Resident Engineer:**Pursell, Gary**Address:** 333 Burma Road**City:** Oakland, CA 94607**Report No:** WIR-013178**Date Inspected:** 10-Apr-2010**Project Name:** SAS Superstructure**OSM Arrival Time:** 700**Prime Contractor:** American Bridge/Fluor Enterprises, a JV**OSM Departure Time:** 1900**Contractor:** Zhenhua Port Machinery Company, Ltd (ZPMC), Changxing Island **Location:** Shanghai, China**CWI Name:** Li Yang**CWI Present:** Yes No**Inspected CWI report:** Yes No N/A**Rod Oven in Use:** Yes No N/A**Electrode to specification:** Yes No N/A**Weld Procedures Followed:** Yes No N/A**Qualified Welders:** Yes No N/A**Verified Joint Fit-up:** Yes No N/A**Approved Drawings:** Yes No N/A**Approved WPS:** Yes No N/A**Delayed / Cancelled:** Yes No N/A**Bridge No:** 34-0006**Component:** OBG**Summary of Items Observed:**

On this day CALTRANS OSM Quality Assurance Inspector (QA) Joe Alaniz was present during the times noted above for observations relative to the fabrication of the SAS Superstructure being performed by Zhenhua Port Machinery Company (ZPMC)

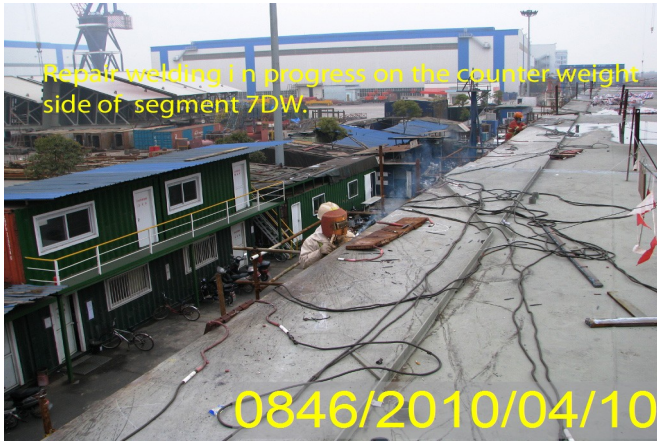
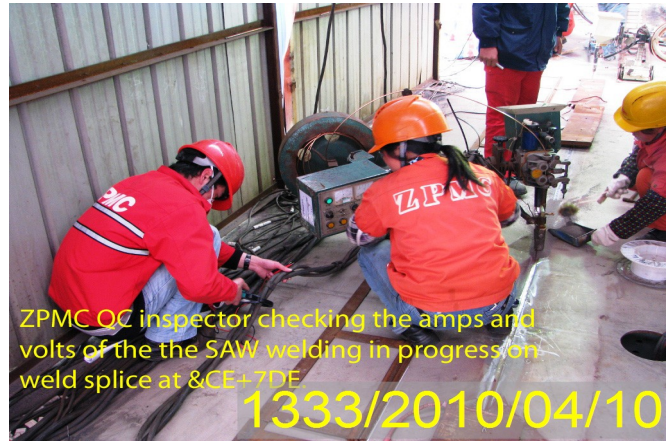
Unless otherwise noted, all work observed on this date appeared to generally comply with applicable contract documents.

Shield Metal Arc Welding (SMAW) VT repair welding was performed on weld joints 07~12 located on DP648-001 cross beam side of segment. Welder is identified as Mr. Bi Shijian (068761). ZPMC QC is identified as Li Yang. The welding variables monitored and recorded by the QC appeared to comply with WPS-345-SMAW-4G (4F)-Repair-1.

Shield Metal Arc Welding (SMAW) repair welding was performed on weld joint 004 located at CA043 counter weight of segment. Welder is identified as Mr. Yun Chuansheng (066002). ZPMC QC is identified as Li Yang. The welding variables monitored and recorded by the QC appeared to comply with WPS-345-SMAW-2G (2F)-FCM-Repair-1 and CWR1377 repair procedure.
